Final Report
San Mateo Project

Florida State University
Emergency Management and Homeland Security Program
San Mateo, San Pedro, Belize

Summary of Project

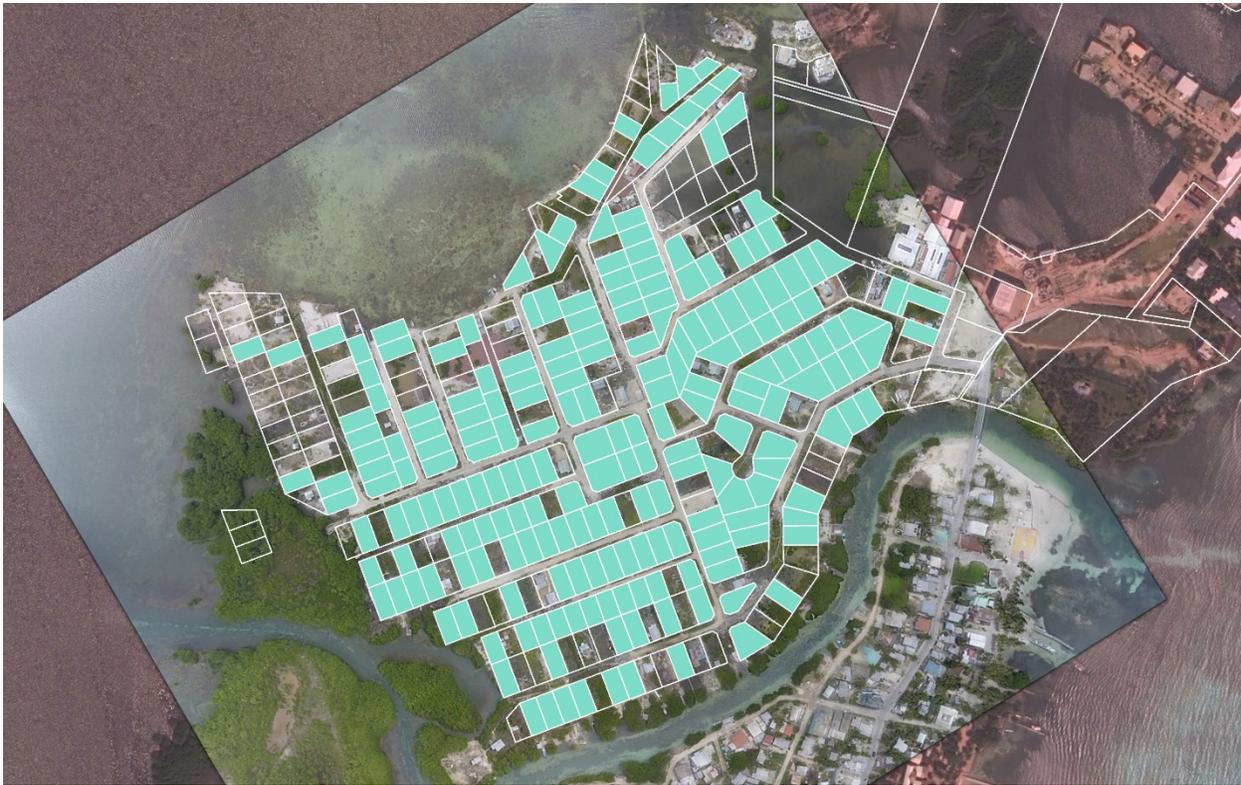
Figure 1. Single family residences

Lots that bear **single-family residences** were the most prevalent. Although initial suspicions would have placed multi-family structures above single-family, the preceding image illustrates the contrary. There is no evident pattern to the placement of the lots with single-family structures as compared to others. However, a number of lots maintained multiple single family structures. This may suggest that a portion of these lots contain informal disconnected duplexes or apartment buildings. However, for the purposes of this study, any standalone structure with one family residing in it was considered a single-family residence, regardless of the quantity of those structures.

Of the 274 single-family structures, 267 (97%) were made primarily of wood, and 82 of those included metal in the construction. Others were improvised, entirely metal, or used masonry in construction. Most of these structures, 243 (89%), were one story, and the remaining were two story. Because of the climate, low elevation, and frequency of storms, most of the homes are elevated. There are 250 elevated single-family homes, and 233 of those were elevated with wood construction.

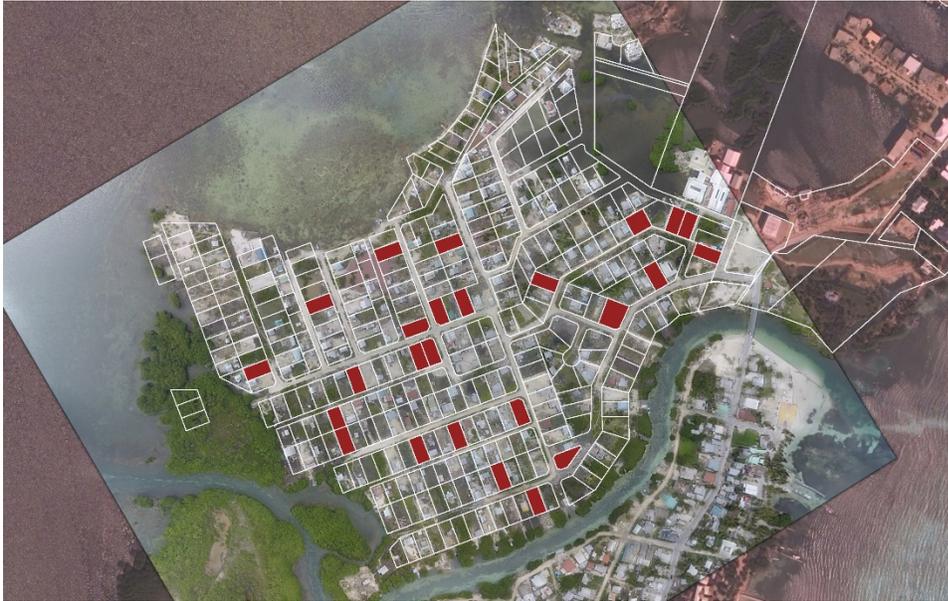
Figure 2. Duplex homes (2 units)

Multi-family residences, including duplex homes or apartments (figure 2) and single structures with multiple families residing (figure 3), were less common than anticipated. There are far fewer lots with multi-family structures than single family. This indicates that individuals are

There were 27 total multi-family homes in the community. Of those, 100% used wood in construction. While a few used metal in roofing or masonry in construction, wood was certainly the preferred medium. A greater portion of multi-family homes were multi-storied. Again these structures capped at two stories, but almost half were that high. Two storied multi-family homes were the least likely to be elevated, with about 25% having no elevation. Of those that were elevated, all used wood.

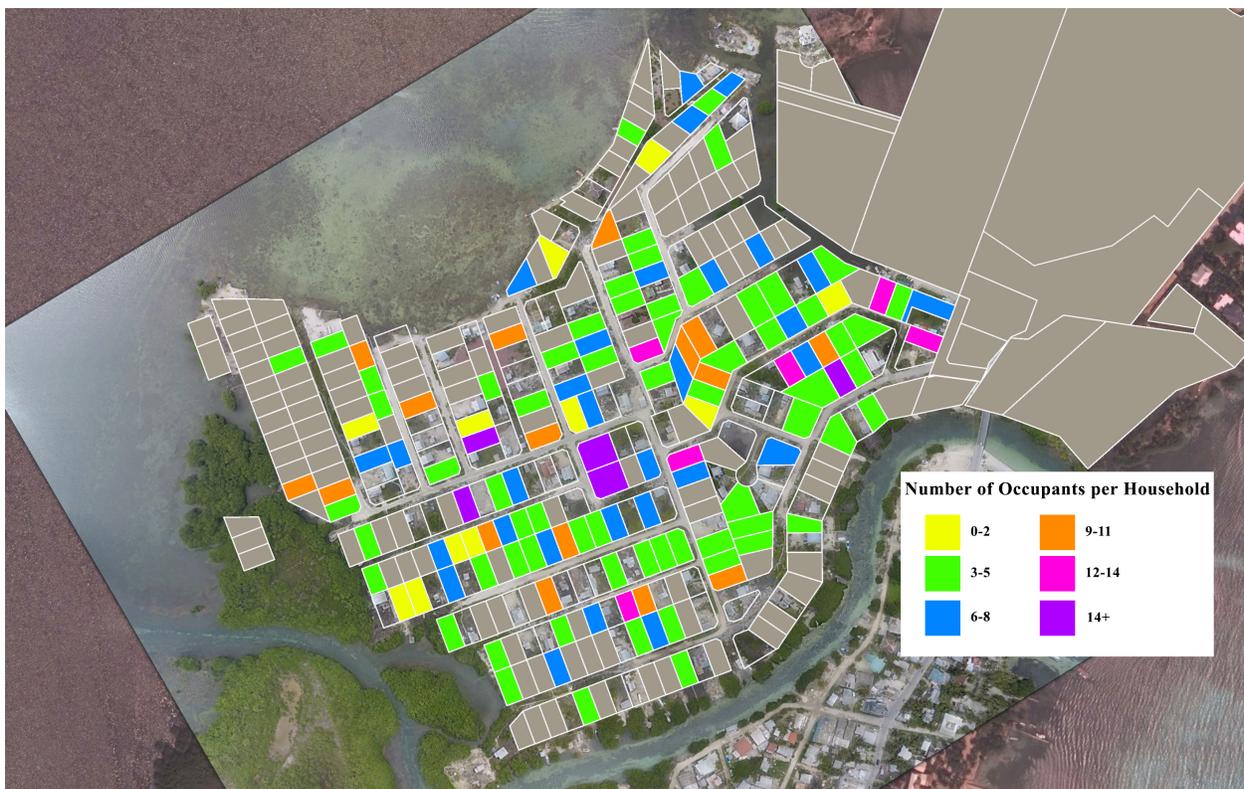
Figure 4. Number of occupants per lot

Because most of the residences were single-family structures, a majority only housed 3-5 individuals. Those lots that had 0-2 were rare and were generally made up of a couple with no children. Homes with 6-8 occupants were either multi-family structures or single-family structures with multiple families residing. Less often, homes with 12 or more occupants were found. Very often, these were larger lots with multiple structures varying in size and occupancy or intention.

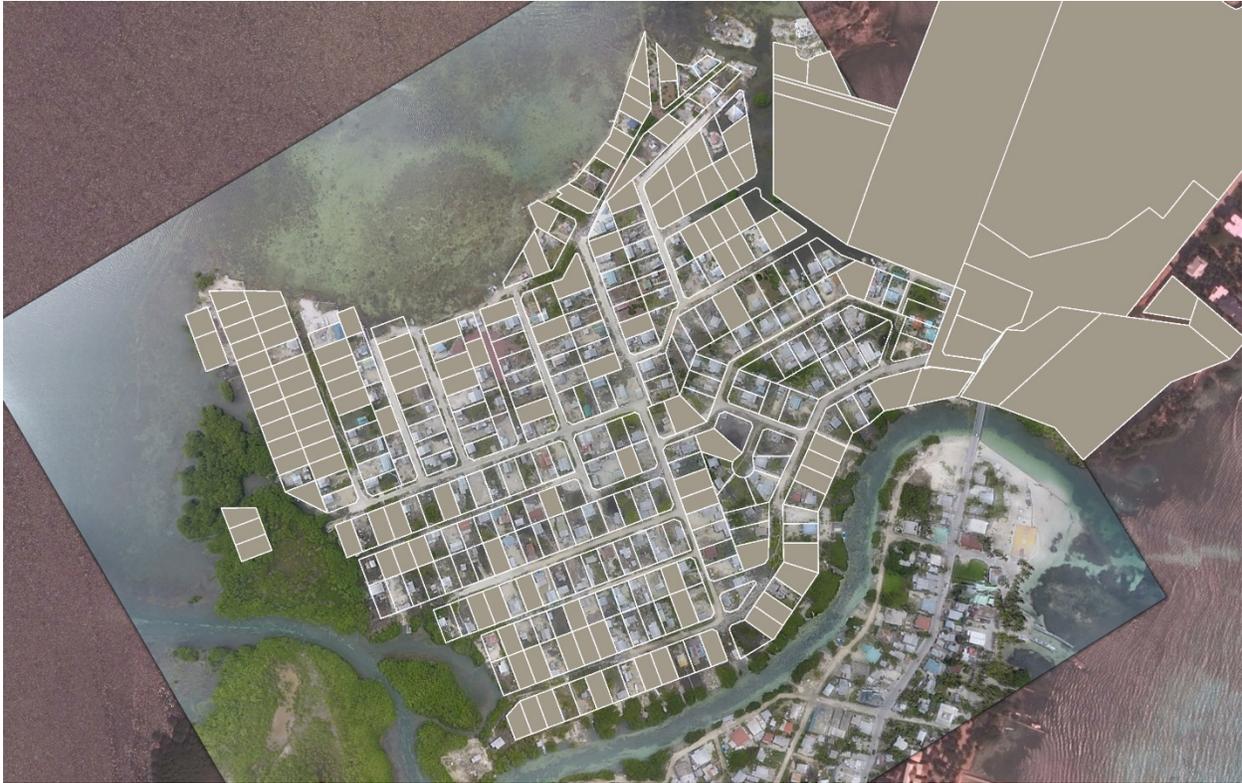
Figure 5. Vacant lots contained wither abandoned or no structures

There were many **vacant lots** in this area. These were lots that either contained no structure at all or contained partially-built or abandoned structures. Predominantly, the lots were completely empty and contained only mangroves, water, or other detritus. Despite the absence of a predictable trend of vacant lot orientation, they elucidate the community's origins and future growth trends. The center of San Mateo accommodates the preponderance of the occupied lots, while vacant lots are in greater numbers along the coast or where copious inland water has yet to be displaced. Vacant lots are common along the waterway on the lower constraint of the foregoing image or along the water in the upper right.

The vacant lots found amongst the central component of the landscape have no discernible pattern to either structure fill or location. There are 74 recorded vacant lots, or about a quarter of the community. A few had dilapidated or abandoned structures, while most were completely empty.

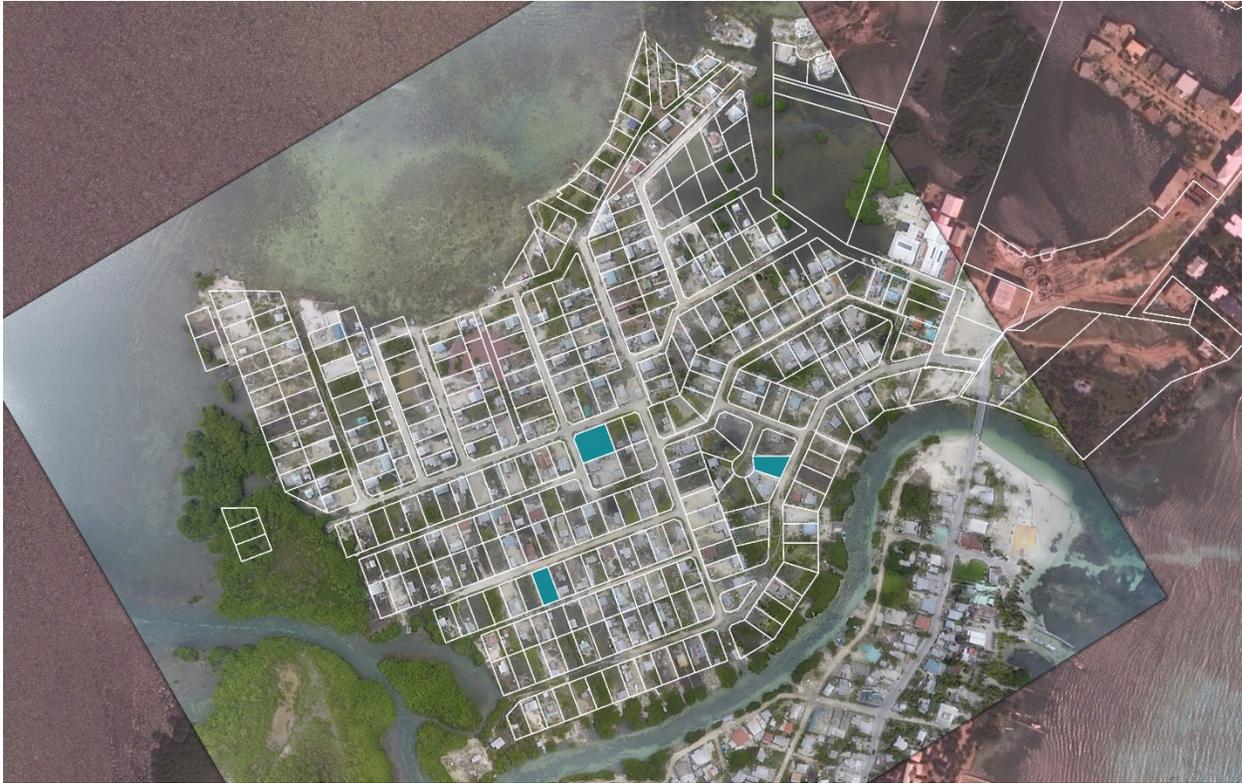
Figure 6. Lots with structures used as churches

There were three lots in San Mateo that furnished churches. One is housed in a centralized lot, while the two others lie southwest and southeast of center. Each of the lots had more than the one structure, illustrating that lot owners were using parts of their own lot for religious fellowship with their neighbors. Upon considering the land constraints found in San Mateo, this land use manifests the importance of theological prioritization to the residents.

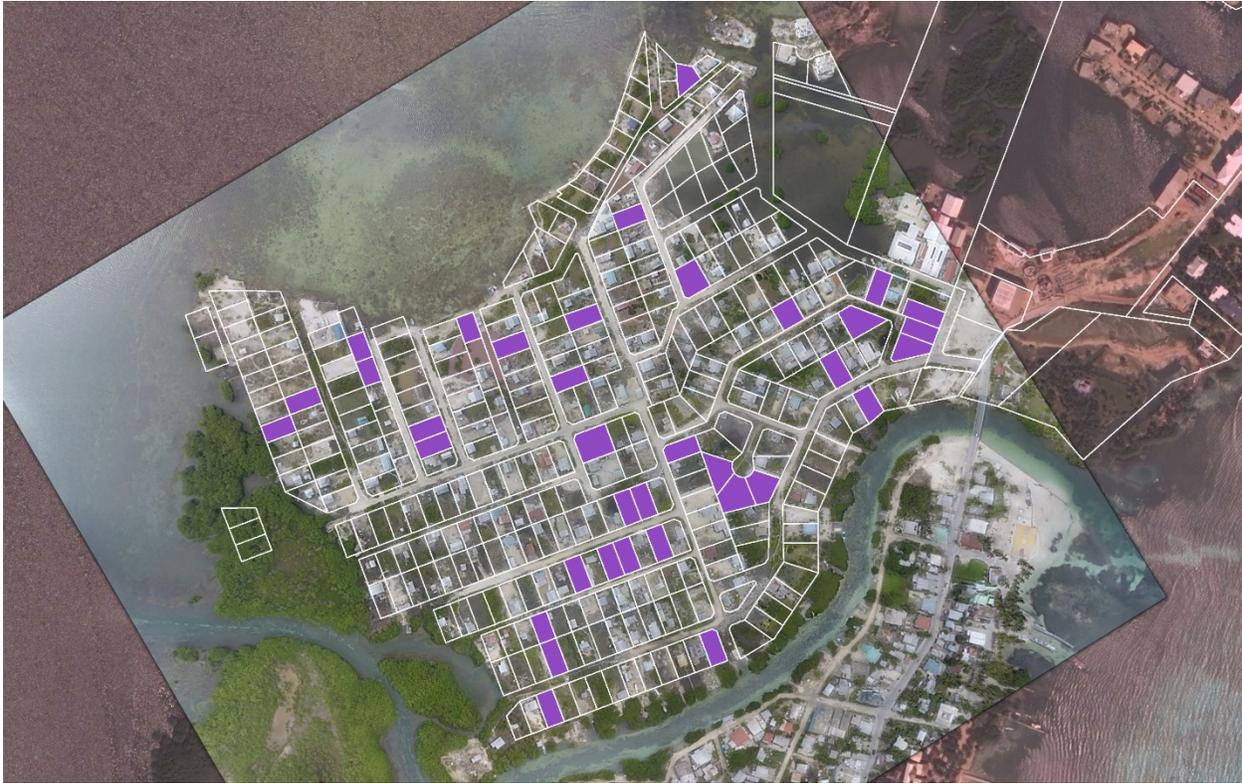
Figure 7. Lots with structures used as sheds

Many of the lots contained sheds, or improvised structures intended for storage. A profusion of the residents tailor these sheds to accommodate the nature of their work, creating items to sell at markets or preparing fruit or food that will be brought to market. The lots with sheds are sporadically placed throughout the map, signifying that sheds are not necessarily indicative of a particular location, lot size, or lot quality.

Of the 35 sheds in the community, most were constructed with wood, though many others used a combination of wood and metal construction. They averaged about 44.1 cubic feet in volume, though some were substantially larger than others.

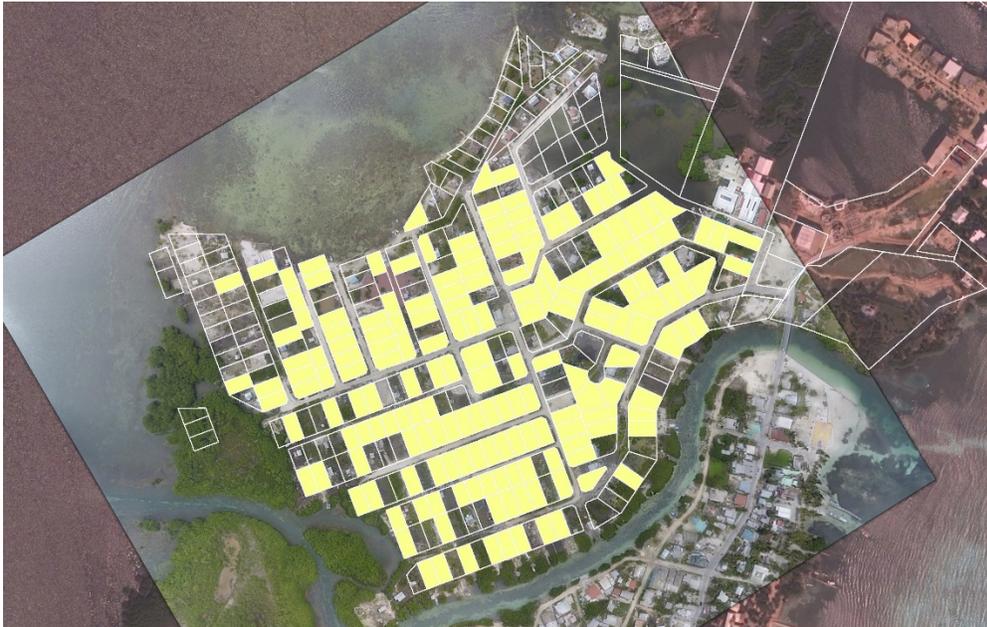
Figure 8. Lots with structures with electricity

Electricity was present to 236 (52%) structures in San Mateo, yet the sources and integrity varied. The bulk of structures with power (figure 8) had lines originating on the main power line. These were installed approximately five to six months prior to our visit, according to the residents. Some lots had improvised power, whether split lines or a simple extension cord running from a neighbor's house. Those without power (figure 9) did not have power of any kind available in their home. While many of these lots were found on main roads, residents reported that they were responsible for the creation of a "power pole" to house a meter and serve as a

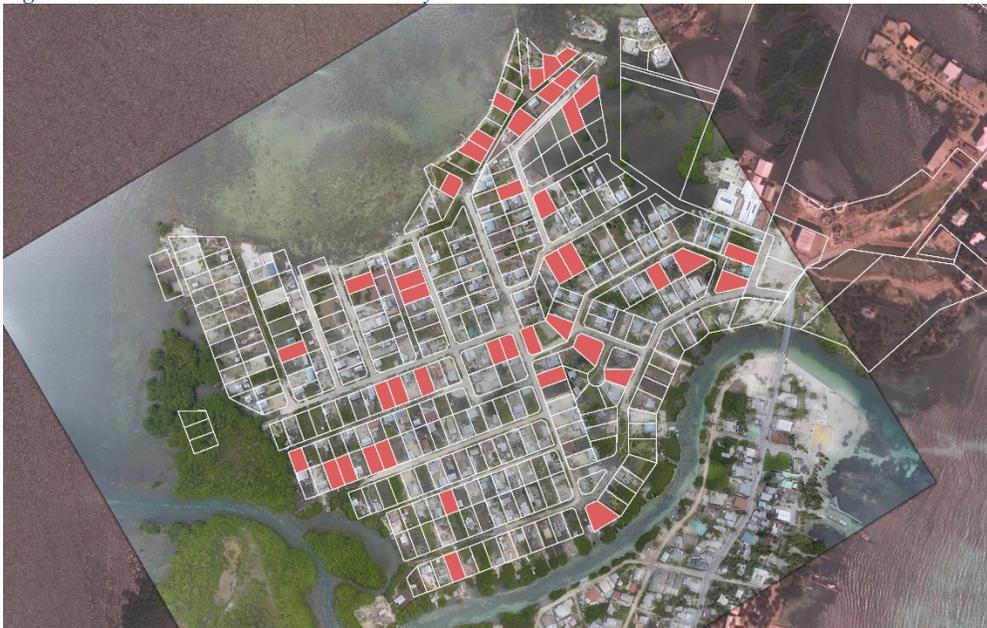
Figure 9. Lots with structures without electricity.

means to split off from the main line. This added cost was the cause for many of the powerless homes to remain in their current state.

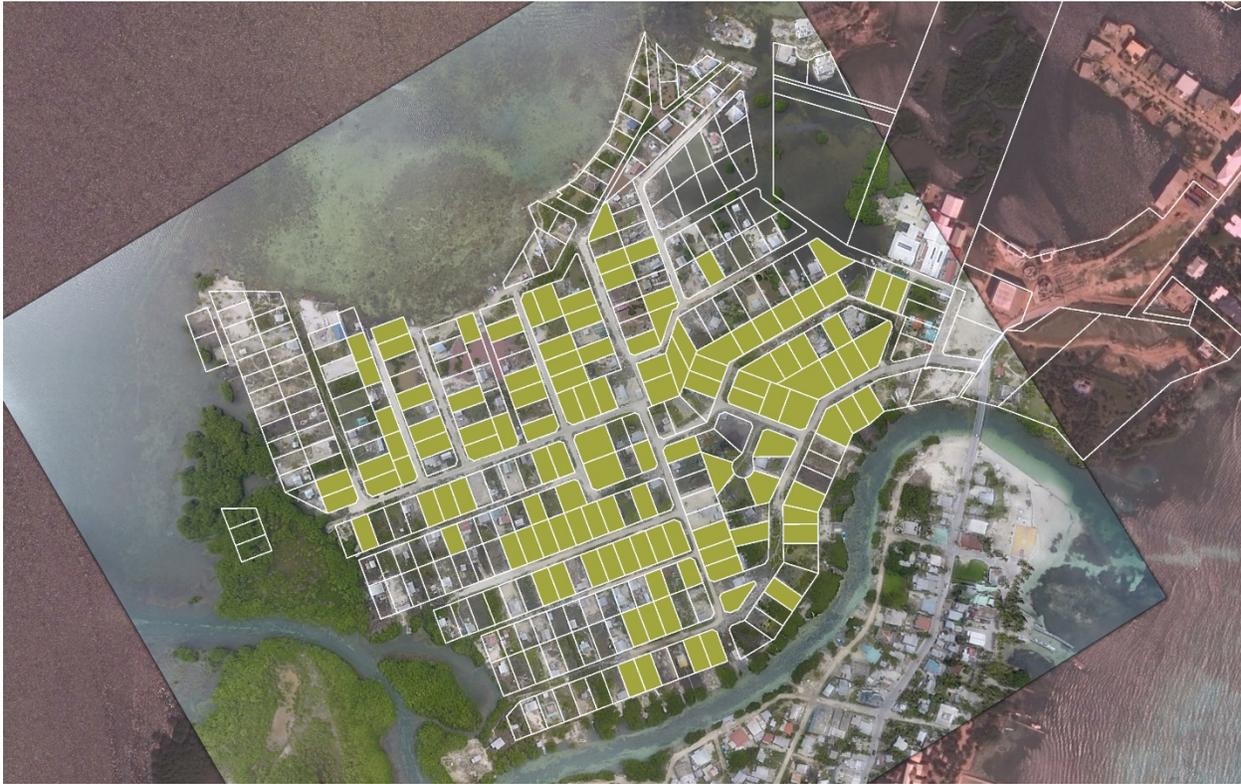
Figure 10. Lots where electricity was metered from a box on the property

Those with power from the main power lines were provided electrical boxes outside their homes with meters. These were either placed on the structure, on the pole, or, somewhat commonly, on cement slabs that stood along the road just outside the home. However, as stated, the residents were responsible for housing this electrical meter. Most of the homes with power along the center of San Mateo had electrical boxes, while most of the outer lots with power did not. This indicates that the main line runs through the center of the community.

Of the 236 structures with power, only 146 had an electrical box present, 112 had split lines, and 103 had exposed wiring.

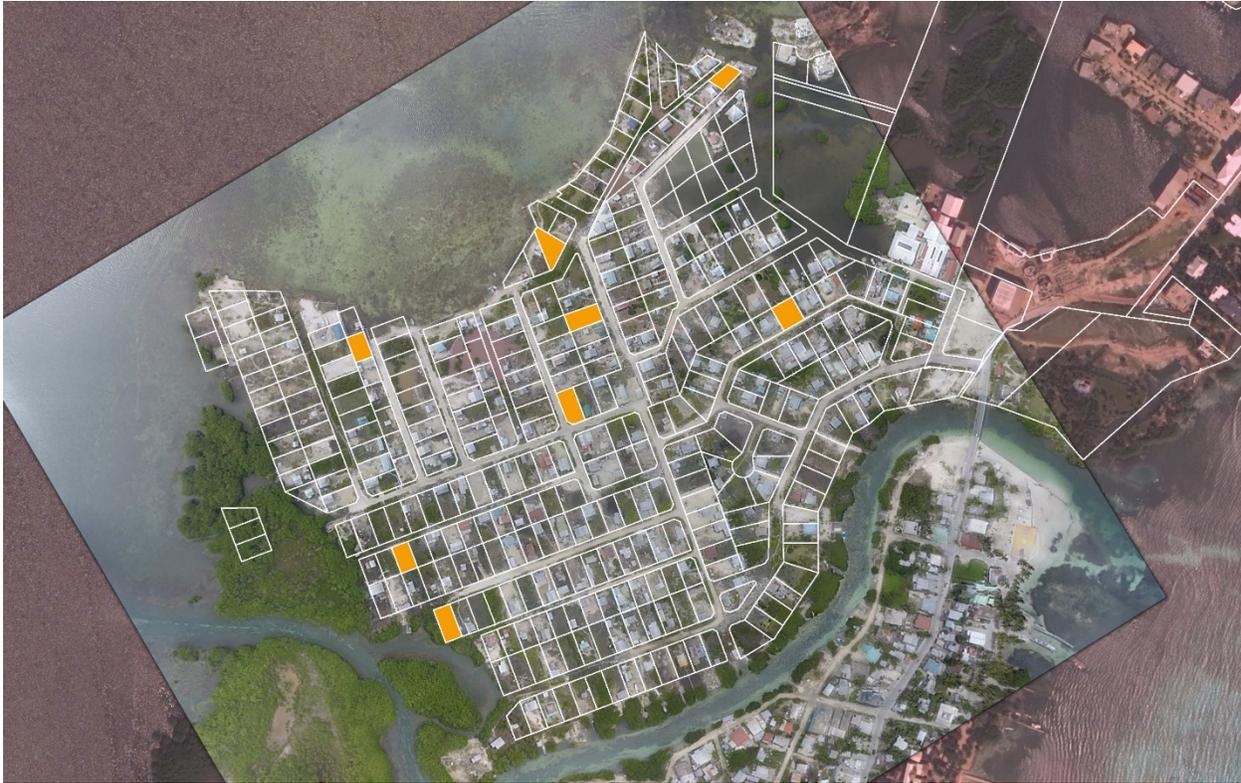
Figure 11. Lots with solar power capabilities

Although Belize is the recipient of year-round direct sunlight, far fewer than expected structures utilize solar power. A meager eight structures, located away from those with reliable electricity maintained these panels. Many of those residents stated the solar panels were only used on occasion. Utilization of solar-derived electricity may be a way for the Belize government to provide reliable electricity to those residents who are not on any power line, or to discourage power sharing in the dangerous methods that have already been used. The size and capabilities of the solar panels found in San Mateo varied immensely. The majority of the few systems present had very low capabilities while a few, well-established, homes maintained systems more extensive capacities.

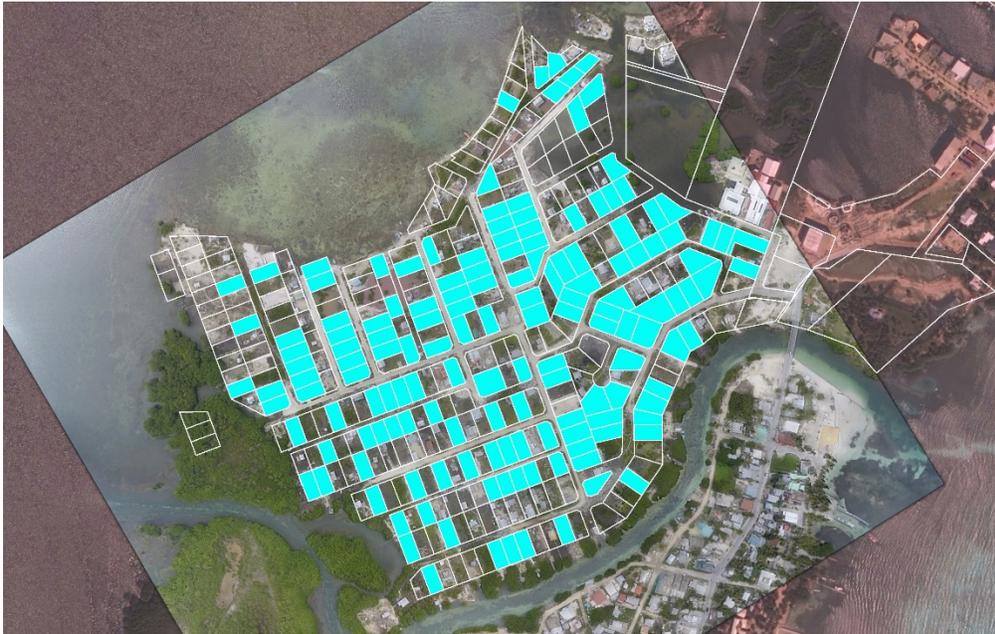
Figure 12. Lots with water from the main water line

Water for these residents was previously provided by the Government of Belize Office Water and Sewer Authority (WASA), but has since been privatized through the Belize Water Services Ltd. This occurred in 2001, but the residents of San Mateo continually stated that they were on the WASA water lines. Nevertheless, a slight minority of lots fall on the main water lines, 176 structures (39%). Again, there is no evident pattern to which fall on the line (figure 12), but when examining the image of lots without connections to the main water line (figure 13) certain rows

Only 64 structures reported that consumable water was present, though the top image indicates a greater number. This would suggest a misunderstanding or miscommunication of the word “consumable” meaning usable or potable. This differentiation could cause confusion even among the researchers. Sharing water from the main line with a neighbor was also present with 116 structures (26%) receiving shared water. There was some overlap in those structures that were on the main line and those that shared from the main line, with 74 (42% of those on the main line) reporting this anomaly.

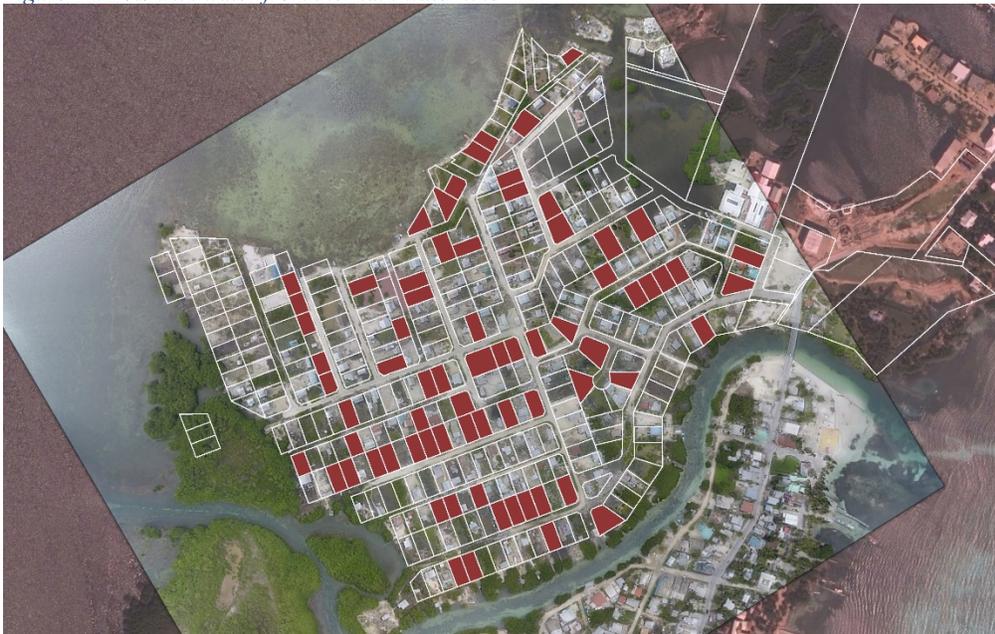
Figure 13. Lots without main line water access

of lots seem to be more susceptible. This may indicate that those lots were planned after the lines were created, and no extensions were put in place before structures were placed. Residents that were connected to main water did not drink the water, but did use it for washing.

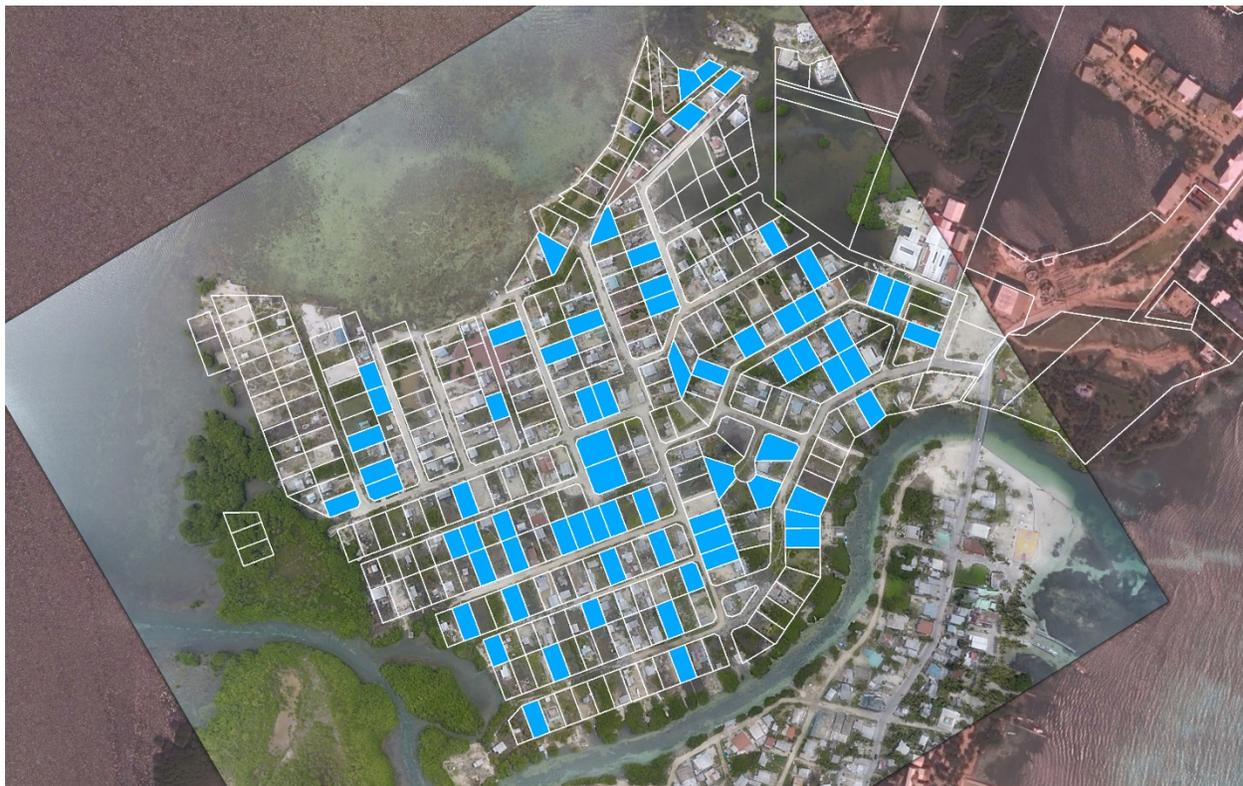
Figure 14. Lots where cisterns were present in any form or capacity

Cisterns were less popular than originally assumed, with only about a quarter or so of the lots having one on property. There is no evident pattern to the distribution of lots with cisterns, though they do seemingly coincide with lots that are not on the main water line. Some cisterns were used for drinking water, but most were strictly for washing, just as the “WASA” water.

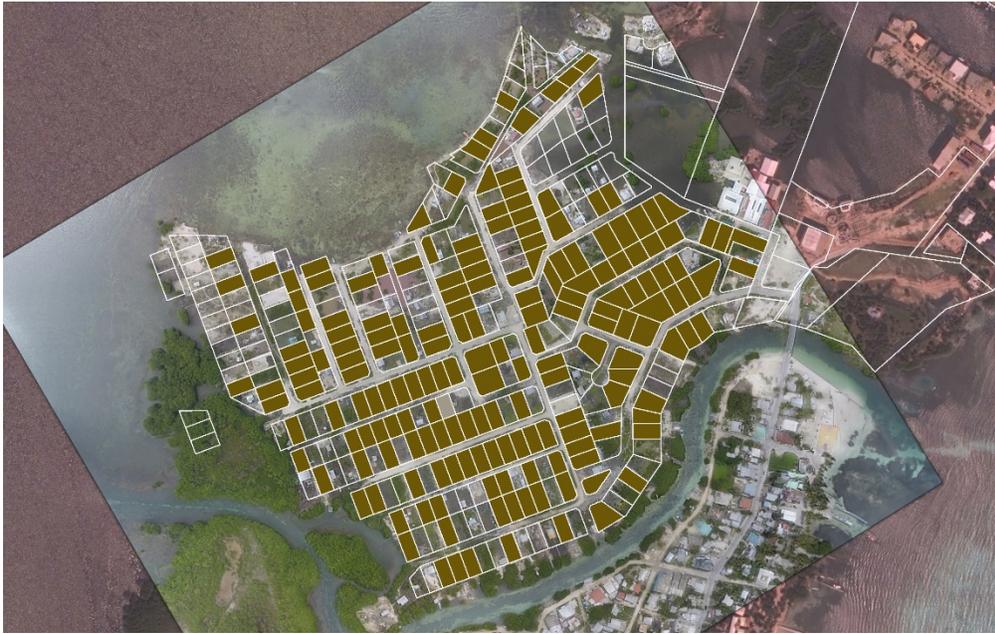
Figure 15. Lots where waste removal systems are present

Most lots with structures had some sort of waste removal present (figure 15). Most even had above ground septic tanks made from cement blocks. These septic tanks would be used until they filled, then a new one would be built, leaving the older tank to empty over time. Inhabited lots with no waste removal present (figure 16), tended to be on lots secluded from primary roads or access points, lots that may have been an afterthought between two planned rows of lots.

A San Mateo resident of 15 years reported that a majority of the cement septic tanks had open bottoms, only filled with shells and rocks. This construction facilitates the waste to flow easily back into the ground. She said there had been several attempts by the community residents and government alike to formalize waste removal, but none had been successful. This universal trend amongst the septic tank construction has led to the lush population of mangroves, Sargasso seaweed, and other greenery that thrive in the nutrient-rich environment.
